UNDERSTANDING AND PREVENTING STEAM TURBINE OVERSPEEDS

William E. Nelson

Perry C. Monroe, Jr.

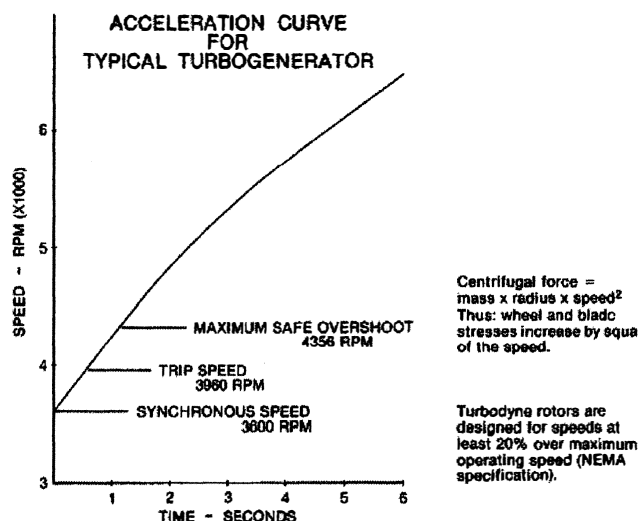
Figure 1. Simplified Acceleration Curve for a Typical Turbine Generator [5].

The load that the turbine is driving and how fast it can change is another major factor in loss of control. A turbine driving an electric generator can suffer a 100 percent load loss in a few cycles or about 1/20th of a second as shown in Figure 1 [5]. The generator is probably more sensitive to overspeed damage than the turbine driver. Rotor design of the two pole generators makes the securing of the windings in the slots difficult. With the windings held in place by the varnish and a few wedges in the slots, an overspeed can cause rupturing of the heavy retaining rings at each end of the rotor. This will dislodge the rotor windings, causing major damage to the stator as well. In some failures, the stator copper can stop the rotating assembly almost instantly, causing the shaft to snap, leaving the turbine completely unloaded from that point.

The overall control scheme of a steam turbine consists of an operating speed governor, as discussed previously, and a separate shutdown system to prevent overspeed. Such a system for a mechanical (MHC) governor is shown in Figure 6 [10]. In the event the speed regulating governor fails to control the speed of the turbine, a fraction of a second is all the reaction time available to sense an overspeed, start, and complete the correction process. Overspeed shutdown systems generally begin to function at 110 percent of design speed and *must* function to stop the steam flow in less than one second completely if no damage is to occur, as shown in Figure 1.

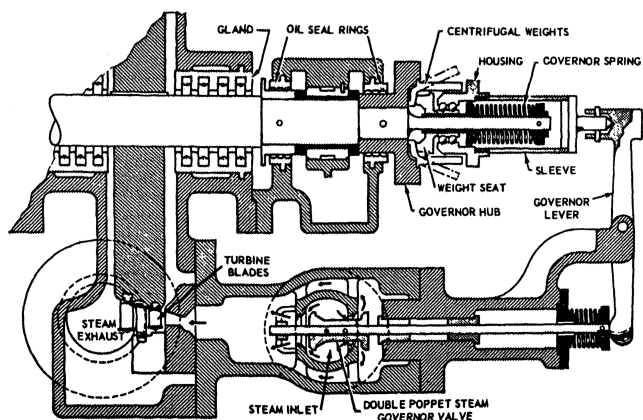
Figure 2. Small Single Stage Velocity-Compounded Turbine with Mechanical Governor [9].

In smaller turbines, all the steam flows to the turbine nozzles through a single, double seated valve, characterized by high flows with low lift and low unbalance forces. Quantity of steam passing through the nozzles is regulated by throttling the steam pressure, as shown in Figure 2 [9]. At low loads, the turbine will be very inefficient because of the energy dissipated by excessive throttling. To improve this situation, one or more hand valves can be provided. Each hand valve will remove some nozzles from service, reducing the available nozzle area and limiting the wasteful throttling.

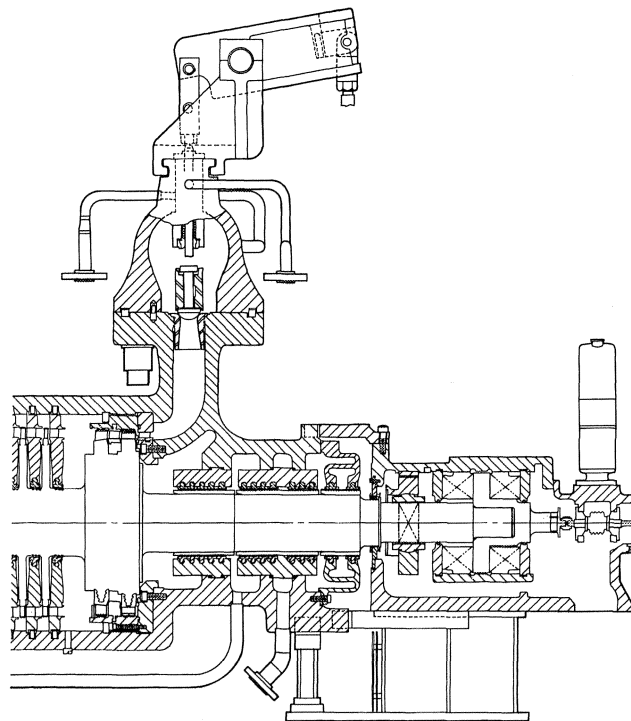
Figure 3. Larger Turbine with Governor Worm Gear Drive and Dished Disk Overspeed Trip [10].

Lifting Bar Type of Control Valves—On some multivalve machines, venturi valves are lifted by a bar mechanism, as shown in Figure 3. The valves have different stem lengths to allow them

to be lifted from their seats, in the proper sequence, as the entire bar is moved. Motive force to move the valves in the closing direction comes only from the weight of the valve itself and the unbalanced steam pressures across it.

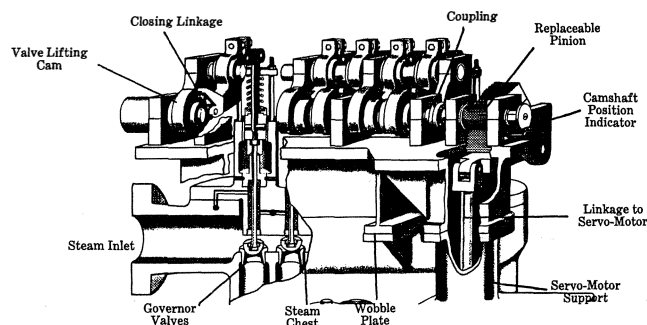
Figure 4. Cam Lift for Multivalve Turbines [10].

Cam Type of Control Valve—Cams mounted on a shaft are another lifting arrangement for valves as shown in Figure 4. The mechanical advantage of the cam geometry produces a large lifting force. Cams permit varying the rate of valve lift vs angular camshaft travel, so the nonlinearity of the valve-flow-lift characteristic can be corrected by the proper cam shape. The camshaft has a gear pinion keyed to it. A rack or gear segment moved by the hydraulic servomotor provides the torque and positioning means required to operate the camshaft and the valve gear. Cam shapes produce a governing point lift of the valve in about 40 degrees of cam rotation. Cam-lift valve gear uses spring force on the valve stem plus the valve-disk steam load to close the valves. Spring force is enough to counteract the valve steam unbalance force plus one hundred to five hundred additional pound biases at the valve-cracking point lift. In addition, some designs have a pin on the cam that can provide a "knock down" force to aid in closing the valves.

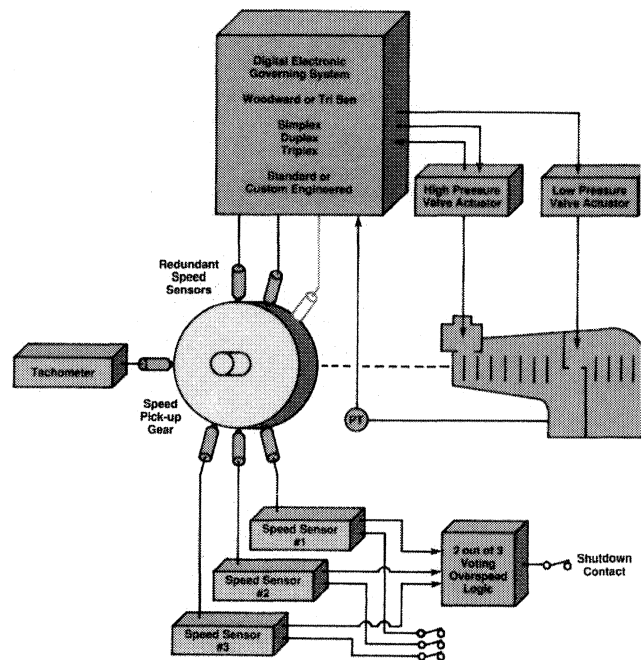
Figure 5. Electronic Governor and Overspeed Trip System [5].

- Class D—Electronic—The electronic governor speed measurement signal is generated by a magnetic pickup in proximity to a toothed wheel or gear mounted on the turbine shaft, as shown in Figure 5. An I/P controls the output air (normally three to 15 lb) that goes to the actuator on the inlet steam valve(s) of the turbine. The design can have redundancy and require little

Solenoid valves can be used to shut the turbine down in response to low lube oil pressure, remote push buttons, or abnormal process conditions as shown in Figure 5.

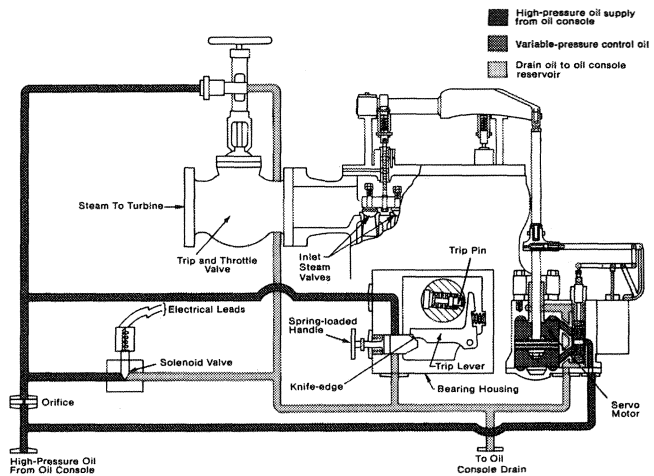
Figure 6. Overspeed Trip System—Large Turbine [10].

On mechanical/hydraulic systems, the unbalanced plunger or pin strikes the trip lever and causes the draining of the trip circuit oil pressure, as shown in Figure 6. When the trip circuit oil pressure drops below about 45 to 50 percent of normal pressure, a piston-spring combination in the trip/throttle valve becomes unbalanced. Force of a spring and the steam pressure above the valve disk slams shut the trip/throttle valve. The dished disk system accomplishes the striking of the oil release device by movement in an axial direction rather than radial; the remainder of the action is identical. All these actions in the valve *must* occur within about one quarter second, so that the total time of action for the three components of the trip system does not exceed about one second.

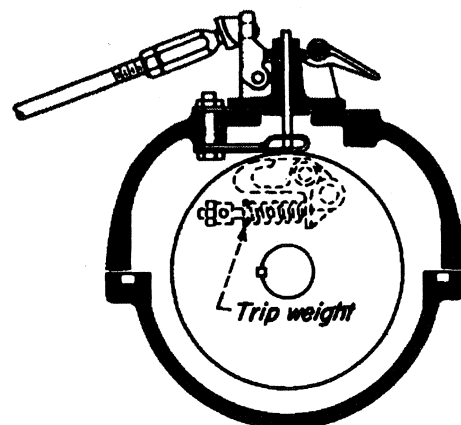
Figure 7. Pivoted Lever Overspeed Sensing Device [9].

- **Pivoted lever weight**—The lever weight is pivoted about a stud and is limited in its movement by a spring as shown in Figure 7 [9]. This type device is used for moderate speeds (up to 4500 rpm) and generally will be found on single stage turbines. Pivoted lever devices can have about ± 3 percent spread between the trip speed on one attempt, and the subsequent trip speed on another attempt. Use of a Teflon® bushing on the lever weight pivot and a stainless steel material for the stud is recommended.

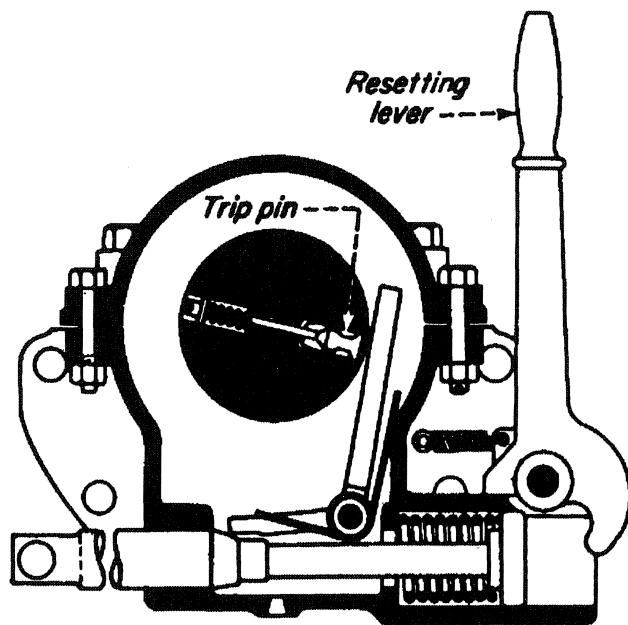
Figure 8. Pin Type Overspeed Sensing Device [9].

- **Pin type weight**—The pin type weight trip is used for higher speed (>3600 rpm) single stage trips and on the larger multistage turbines as a standard, as shown in Figures 5, 8, and 9. Movement of the trip pin is limited to about $\frac{1}{8}$ to $\frac{3}{16}$ in. The tripping speed is adjusted by changing the compression on the emergency spring adjusting screw opposite the pin in most systems. In this scheme, the moment balance on the pin is not changed during normal operation. Usually, the weight balance adjustment nut is on the pin side of the shaft and opposite the spring compression nut adjustment. In other schemes, the emergency weight adjusting screw is for altering the balance of the pin weight to change tripping speed. The spring compression is not used to set the tripping speed under this arrangement. A pin type trip of a cartridge design is shown in Figure 9. This permits setting of the trip off the turbine by using an air motor drive, microswitch contacts on the striking arm, and an electronic tachometer. This is a highly desirable feature on a turbine because of the time and labor savings from not having to run the turbine for adjustments.

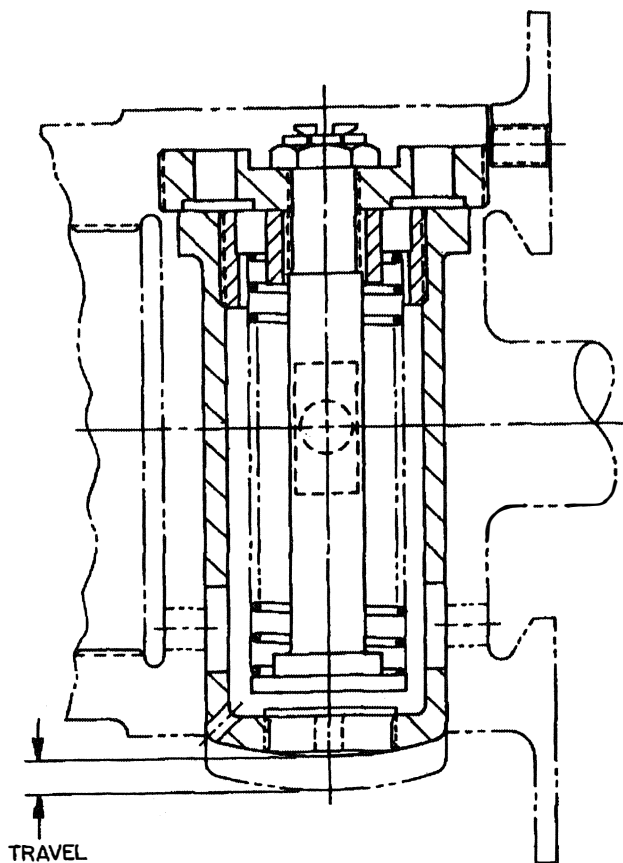
Figure 9. Cartridge Type Overspeed Trip Pin.

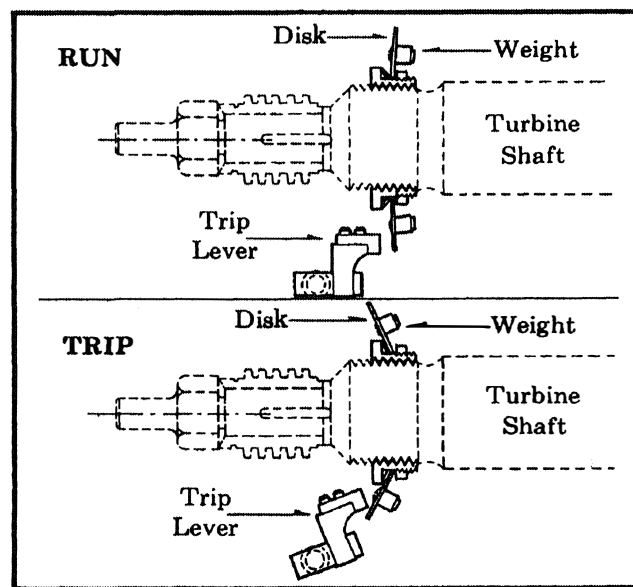
Figure 10. Dished Disk Speed Sensing System [10].

- Dished disk—In this patented design for higher speeds (above 8000 rpm), a dished disk is mounted on the shaft. A series of weights is located around the circumference of the disk to increase the mass as shown in Figures 3 and 10. Dynamic balance of the assembly is inherently stable. At trip speed, centrifugal forces cause the disk to “snap” to the tripped position and strike a trip lever in an axial direction, rather than radial as on the lever or pin designs. The trip speed repeatability is very good, about ± 1 percent or less spread.

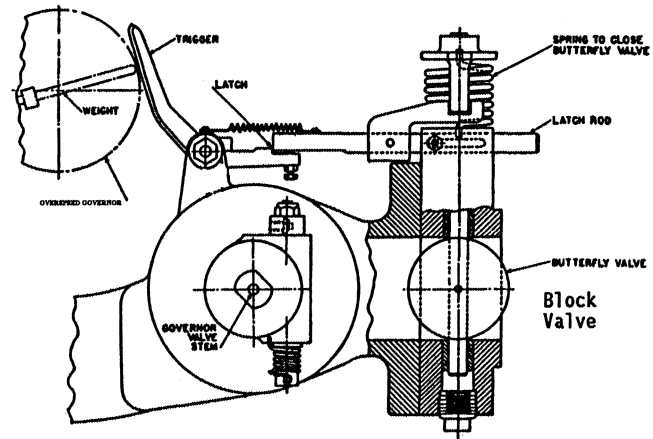
Figure 11. Typical Overspeed Trip System—Small Turbine.

An all mechanical overspeed system, shown in Figure 11, is frequently used on single-valve small machines. A trip pin is mounted in the turbine shaft with its center of gravity slightly off center and possible movement of 1/8 to 3/16 in. When a predetermined speed is reached, the unbalanced plunger or pin overcomes a spring force. As it moves outward about 1/16 in, it strikes the trip-lever, causing release of a spring loaded butterfly valve that stops the steam flow.

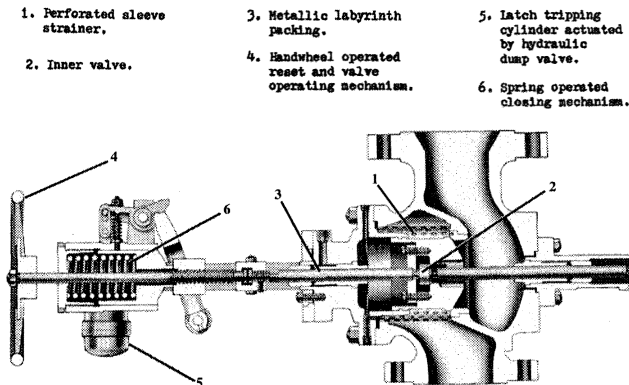
Figure 12. Hydraulic Latch Type Trip/Throttle Valve [15].

- A specially designed trip/throttle valve in a separate casting to the turbine governor or control valve(s), as in Figures 12 and 13. It is spring loaded but hydraulically latched, instead of mechanically released (larger machines from all U.S. turbine manufacturers).

- Disk is pushed onto seat design—In the larger valve sizes, the closing force on the valve stems and split coupling are frequently not adequately designed to withstand the impact load generated by this high closing force and any misalignment. Frequently, damage occurs to stems or the split coupling with the plug pushed onto a seat design. This can cause sticking or retarded movement of the steam valve plug, as shown in Figure 12.

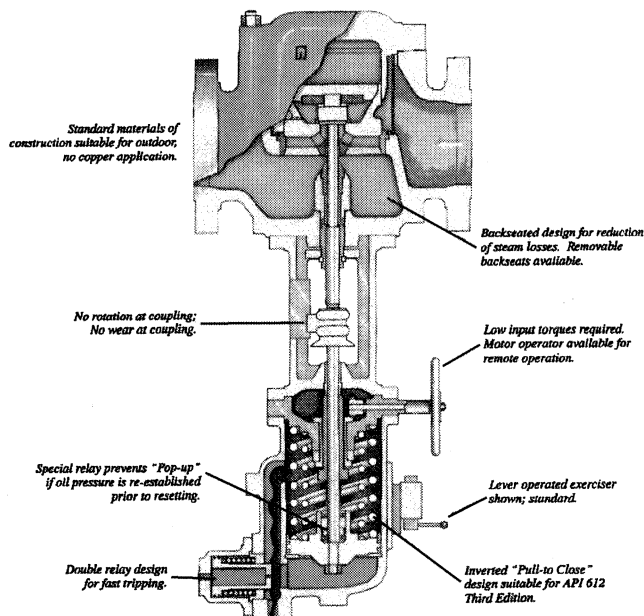
Figure 13. Fully Oil Operated Trip/Throttle Valve Pull onto Seat—Built in Exerciser [15].

- **Disk is pulled onto seat design**—The design that “pulls” the plug onto the seat without a lower guide is the preferable design, since the two stems and the split coupling operate in tension. This seems to limit the mechanical damage to the valve components during the closing action [13, 14]. Details of construction are shown in Figure 13. Also, fewer tight fitting stem areas where steam deposits can collect exist.

A mechanical or test bypass on the hydraulic piston should be installed, so that the valve can be exercised to approximately one-third closed position as frequently as needed. Free motion of this distance virtually guarantees positive tripping action in an emergency. The test bypass is so arranged that motion beyond one third travel cannot be achieved in the test mode, since the hydraulic piston covers the leakage port. Tripping action can take place when in the test mode. The details of how this can be accomplished are shown in Figure 13. Some small percentage of valve “hangups”

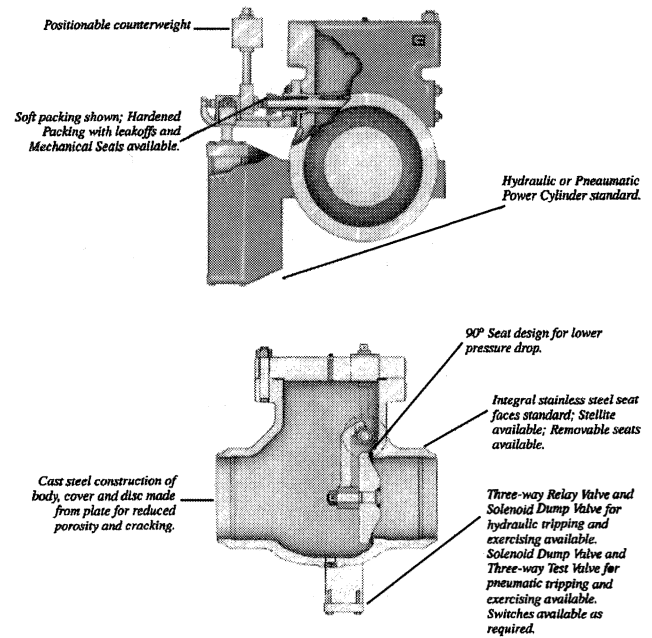
Figure 14. Extraction-Induction/Extraction Swing Disk Nonreturn Valve [15].

- Extraction system nonreturn valves are of a check valve style bolted on the flanges of the turbine shell and activated by the same hydraulic system that closes the trip/throttle valve, as shown in Figure 14.

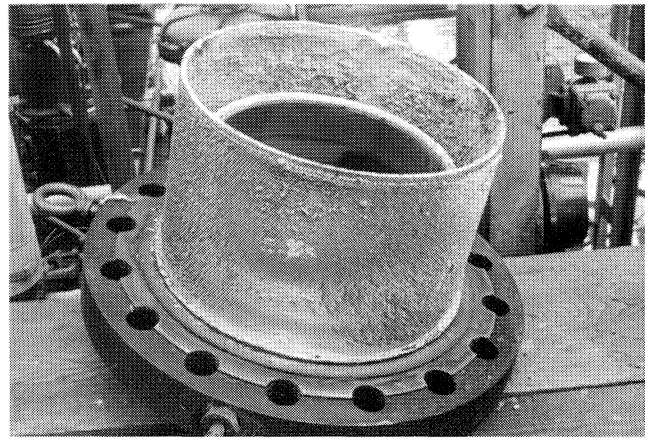
Figure 16. Trip/Throttle Valve Screen with Heavy Carryover Deposits.

The screen shown in Figure 16 is from the trip/throttle valve of a turbine (10,000 hp, 5100 rpm, topping, 415 psig to 115 psig) running in tandem with a Frame 5 gas turbine. Both machines drive a catalytic cracking unit two-case wet gas compressor train. The steam turbine used steam generated in two waste heat boilers by exhaust gases from this gas turbine and another one. The turbine was just downstream of the waste heat boiler. The boiler steam drums had very poorly designed dry pipes. Moisture separation internals in the steam drum consisted of a small area of a wire-mesh-screen over the dry pipe. Moisture and solids carryovers were very high. Steam quality analyzers were installed on the two waste heat boilers outlet pipes. The analyzers alerted operating personnel to the carryover problems, but no corrective actions were taken. Poor steam drum internals and a lack of training for the operating personnel to respond to correct the carryover lead to this problem. It was necessary to shutdown the entire process unit to clean the steam system. A runaway situation was avoided only because the flywheel effect of the gas turbine on the train prevented it. Operating independently, this turbine would have been a catastrophe looking for an opportunity to happen.
